# Oscilloscope Restoration Project – Repair Tektronix 2465B 400MHz

This applies to all similar type models 2445 , 2445A , 2445B , 2465 , 2465A , 2465B , 2467 , 2467A , 2467B and others which share common circuit boards.

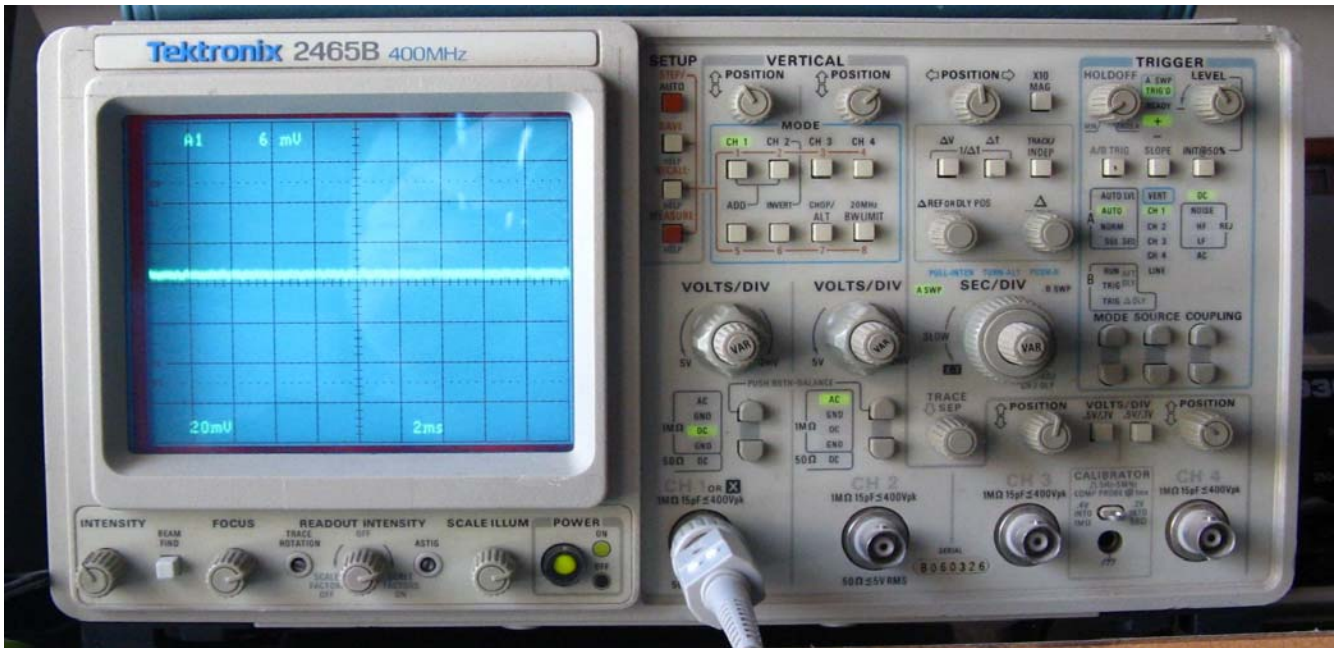
Symptoms: This is my lab unit, which suddenly started blowing its main AC fuse.
